Case Study

Flood Protection: **PFR**

Client: **Mr Bailey**

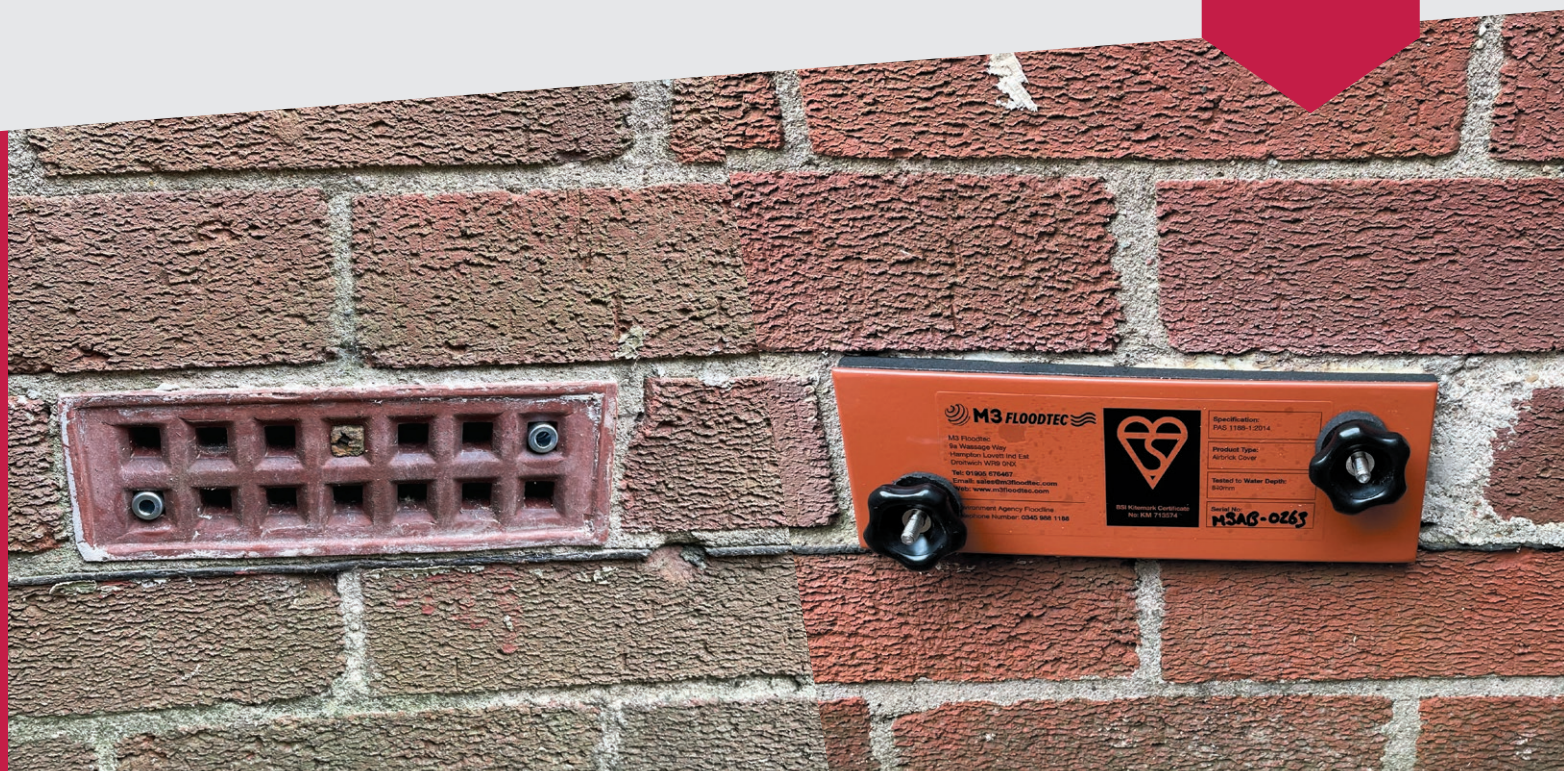
Located in East Yorkshire this property suffered years of damp beneath the floorboards as heavy rainfall build up seeped into the floor void through open airbricks.

Poor drainage around the property meant that the ground could not absorb heavy rainfall such that it built up against the building walls and flooded into the under floor void through the Airbricks around the house. Once inside the slow evaporation of the excess water caused damp and threatened the lifespan of the timber flooring.

Because the building had several different sizes of airbrick the M3 Floodtec proposed deployable Airbrick covers seated with 2 fixings in each brick.

The fixing bolt sleeves remain in permanent position once initially installed so that the covers could be readily installed in the event of heavy rain.
